WRENCH

REALITIES

From time to time I get calls to inspect systems that I did not sell or install. I recently got a call from a gentleman in Oregon complaining about an RE installation. This horror story is particularly interesting because the system in question was designed and installed by a licensed electrical contractor.

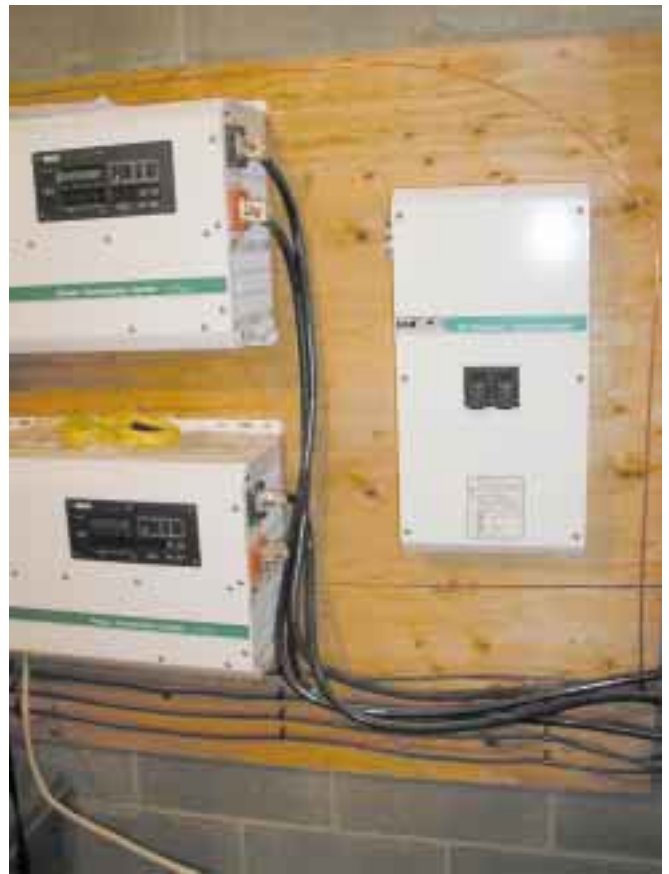
Photo 1

- Single conductor wires not in conduit; *NEC 300.3(a)*
- No conduit box; *NEC 300.15*
- Conductors not protected from physical damage; *NEC 300.4*
- No overcurrent protection; *NEC 240.3*

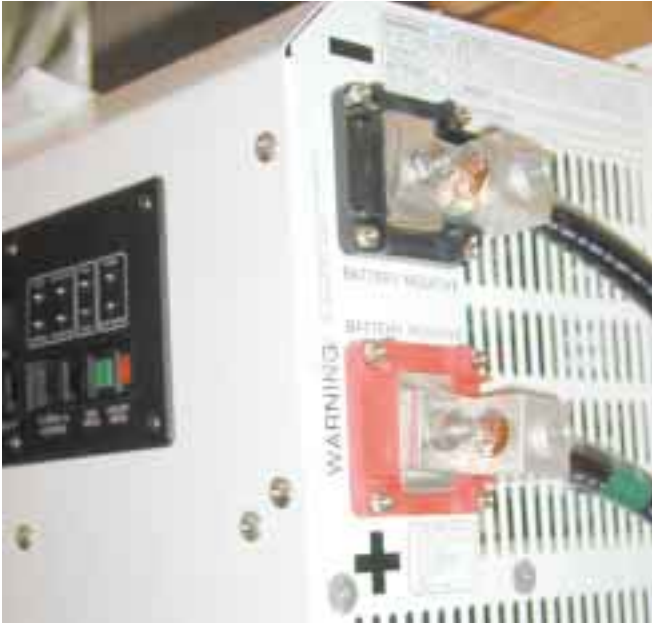
Photo 2

- Single conductor wires not in conduit; *NEC 300.3(a)*
- No conduit box; *NEC 300.15*
- Conductors not protected from physical damage; *NEC 300.4*
- No overcurrent protection; *NEC 240.3*
- Incorrect marking of ungrounded conductor; *NEC 310-12(c)*

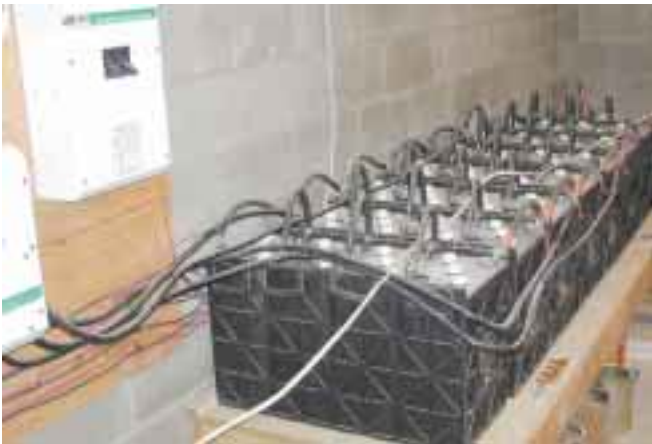
Photo 3

- Single conductor wires not in conduit; *NEC 300.3(a)*
- Conductors not secured; *NEC 300.11*
- Conductors not protected from physical damage; *NEC 300.4*
- No overcurrent protection; *NEC 240.3*
- No battery acid spillage protection; *NEC 480-7(b)*
- No guarding of live battery parts; *NEC 480-8(b), 690-71(b)(2)*
- Ampacity of 12/2 NM Romex between generator and inverter substandard; *NEC 310-15(a)*

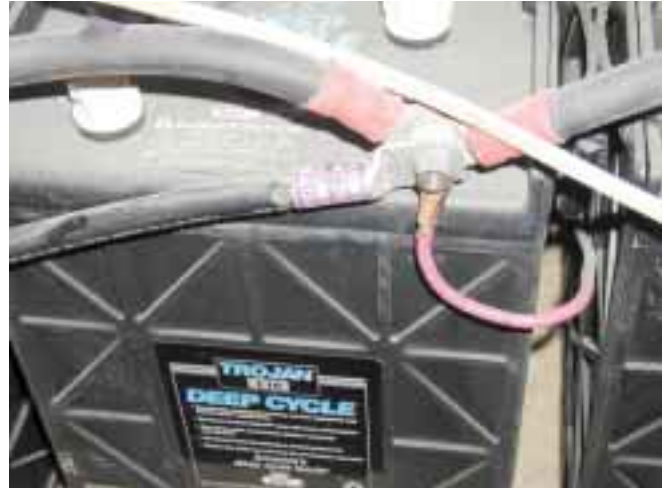
Photo 4

- Conductors not secured; *NEC 300.11*
- Conductors not protected from physical damage; *NEC 300.4*
- No overcurrent protection; *NEC 240.3*
- No guarding of live parts; *NEC 480-8(b)690-71(b)(2)*
- #4/0 inverter wire terminal not protected from corrosion; *NEC 310-9*

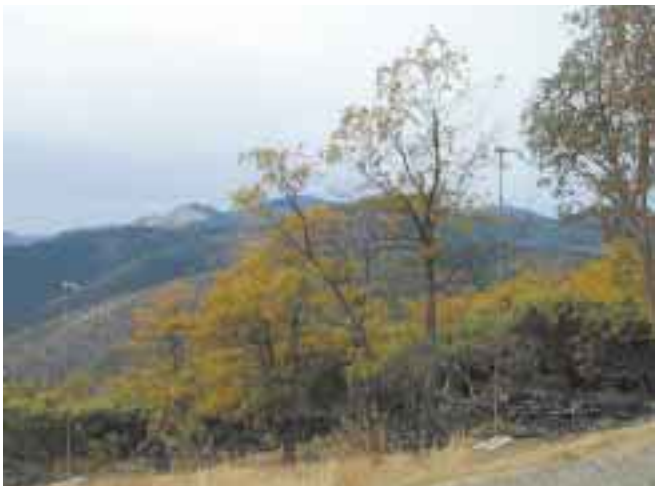
- No load analysis of customer needs done prior to designing system.
- Incorrect tower height specified for wind generators. Generators must be a minimum of 30 feet (9 m) *above* trees and house.

- Size or number of wind generators incorrect for needs and site.
- Too many batteries to be supported by RE system inputs.
- Incorrect type of wire terminals at inverter end of #4/0 inverter feed wires.

Mr. A's poorly sized and sited wind generators.
